A REPORT TO ANY TOWN PRIMARY SCHOOL

A feasibility study for the redevelopment of an informal grass area at Any Town Primary School.

22 May 2013

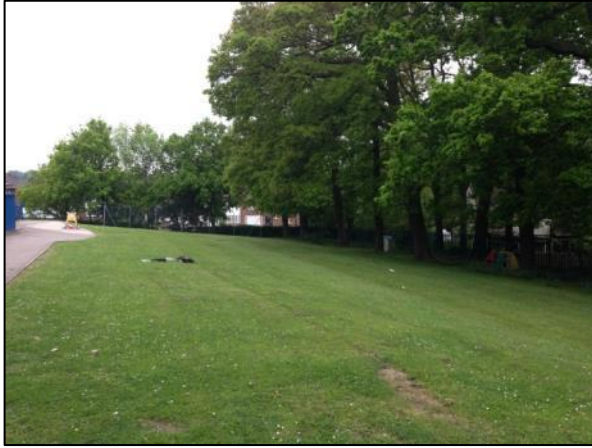
The site currently comprises a small recreation area for informal use by pupils. This is the only outside space available for school use. The site currently has a significant fall from East to West and is therefore unsuitable for most sporting activities. The site is bounded on three sides by residential properties and fields to the north.

Figure 2. General View 1 (GV1) of site looking south-west

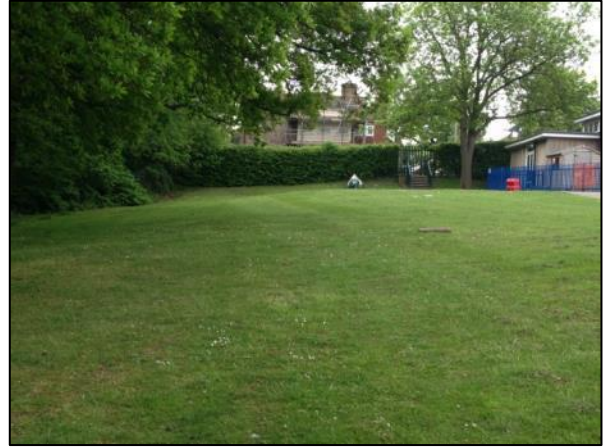
Figure 3. General View 2 (GV2) looking north-east.

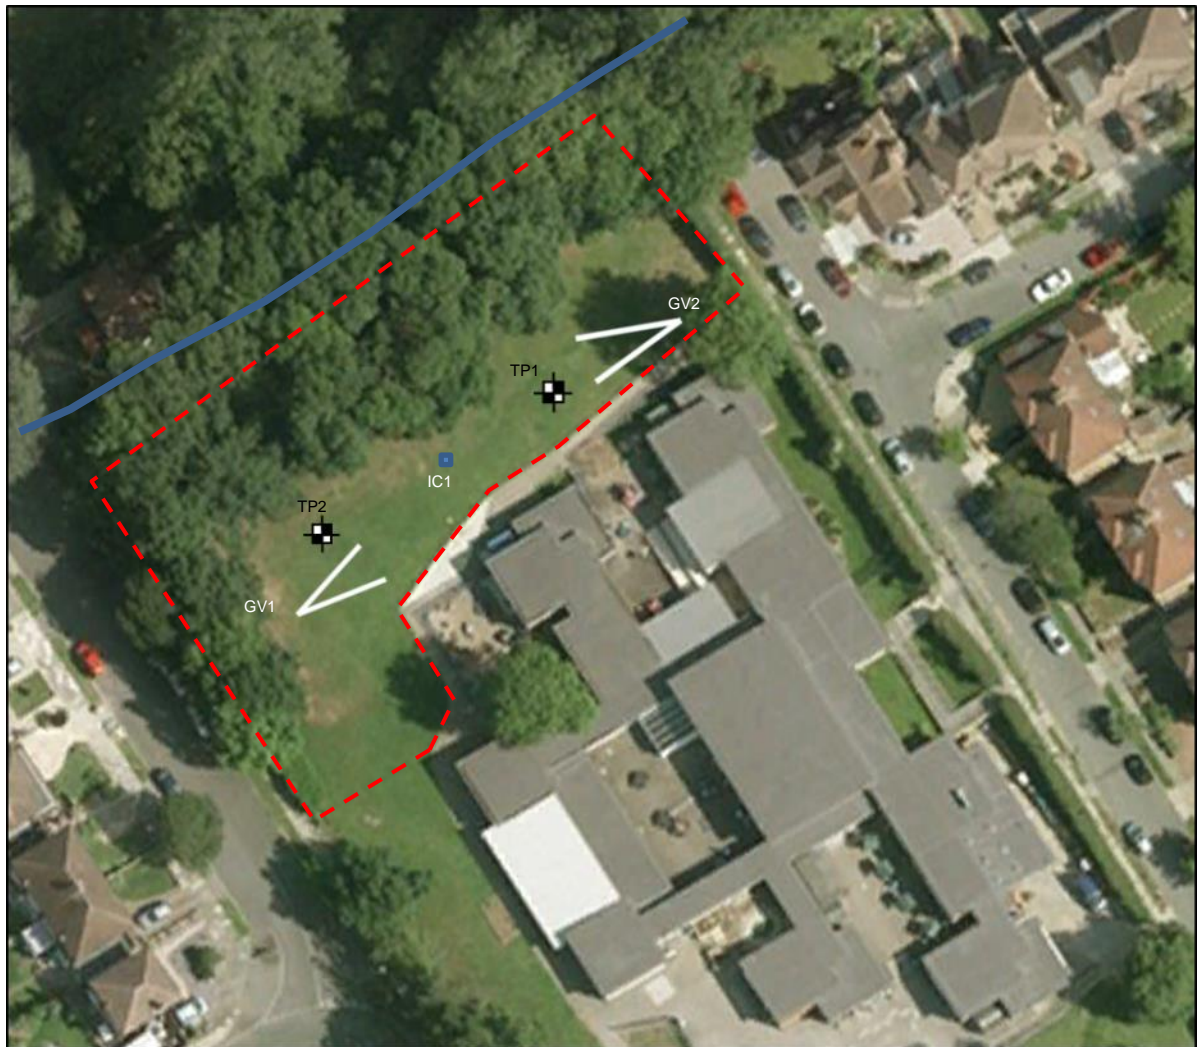
Figure 4 Any Town Primary School re-development. TP1 and TP2 mark the location of the trial pits. The dashed red line indicates the site development area (indicative only – not to scale). GV1 and GV2 are general views of the site and refer to Figure 2 and Figure 3 respectively. IC1 represents an inspection chamber on site and the blue line represents a watercourse leading to a nearby brook.

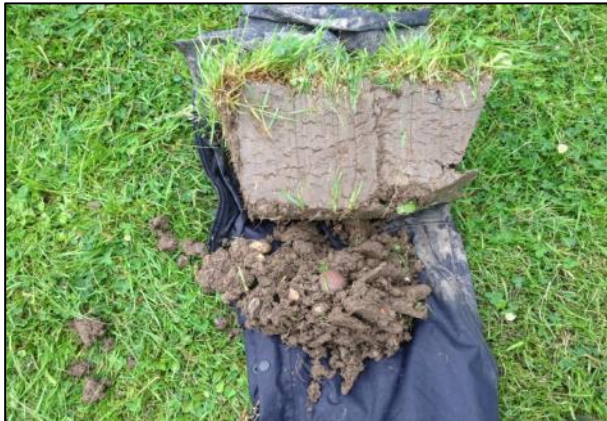
Grass cover was approx. 90% and predominantly annual meadow grass. Rooting depth was typically 100 mm. Thatch depth was <5 mm. Grass heights were maintained at 50-60 mm. Large amounts of invasive weeds were evident in the sward including Daisy, Creeping Buttercup and Chickweed.

No drainage infrastructure was encountered within the trial pit. Surface uniformity within the surrounding area was poor and would benefit from re-grading.

Figure 7 TP1 CLAY LOAM topsoil

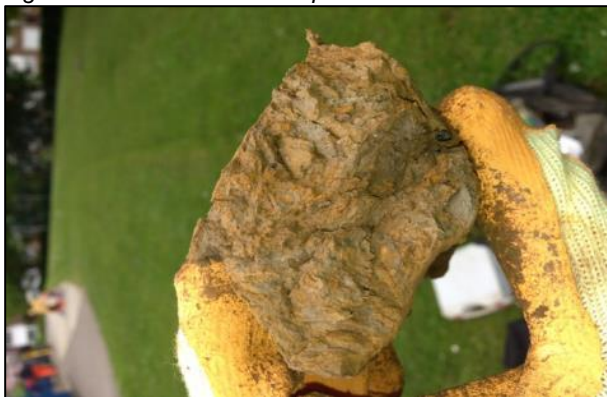
Figure 8 Example of mottled sub soil (TP1)

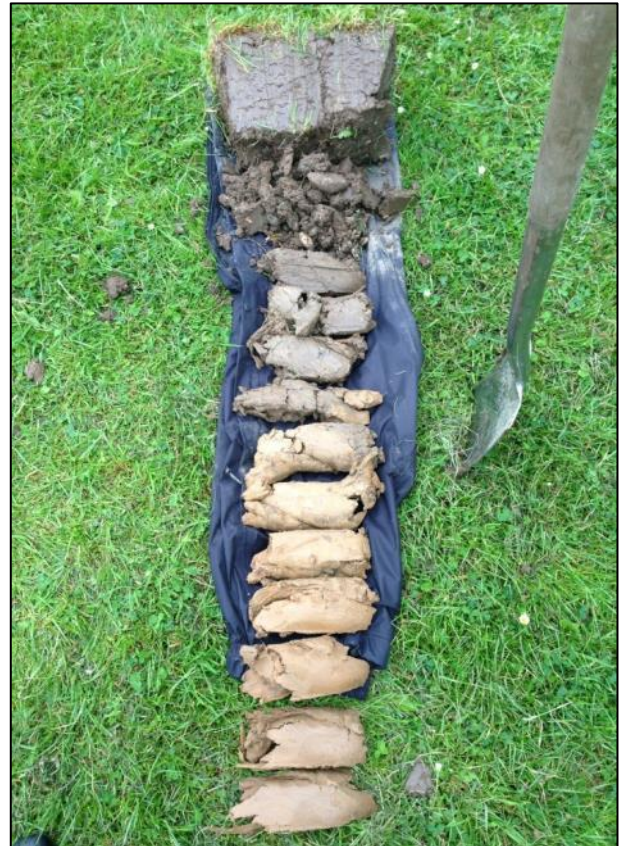
Figure 9 TP1 400 mm CLAY LOAM topsoil over plastic CLAY subsoil, mottled in appearance to a depth of 1000 mm indicative of saturated conditions.

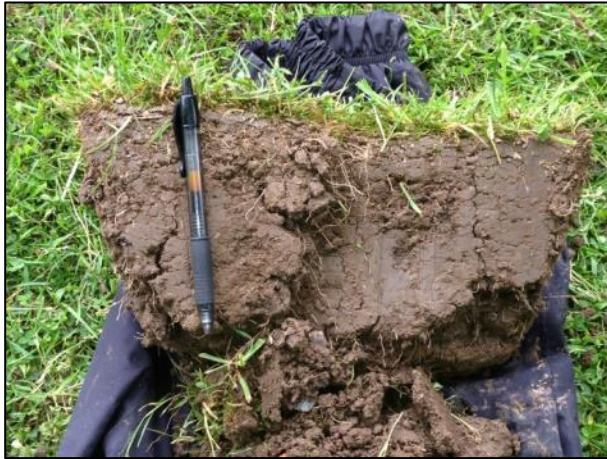
TP2 comprised 450 mm of very stony CLAY LOAM topsoil (Figure 10). Large amounts of stones were encountered at approximately 150 mm in depth. The stony structure of the soil meant augering past 450 mm was not possible. At 300 mm the clay loam became slightly mottled indicating a high ground water table (Figure 11).

Grass cover was approx. 90% and predominantly annual meadow grass. Rooting depth was >250 mm and thatch depth was <5 mm. Weed cover was approximately 70% and consisted of Plantains, Daisy and Creeping Buttercup.

No drainage infrastructure encountered within the trial pit. Surface uniformity was poor with significant undulations.

Figure 10 TP2 Poorly structured CLAY LOAM topsoil

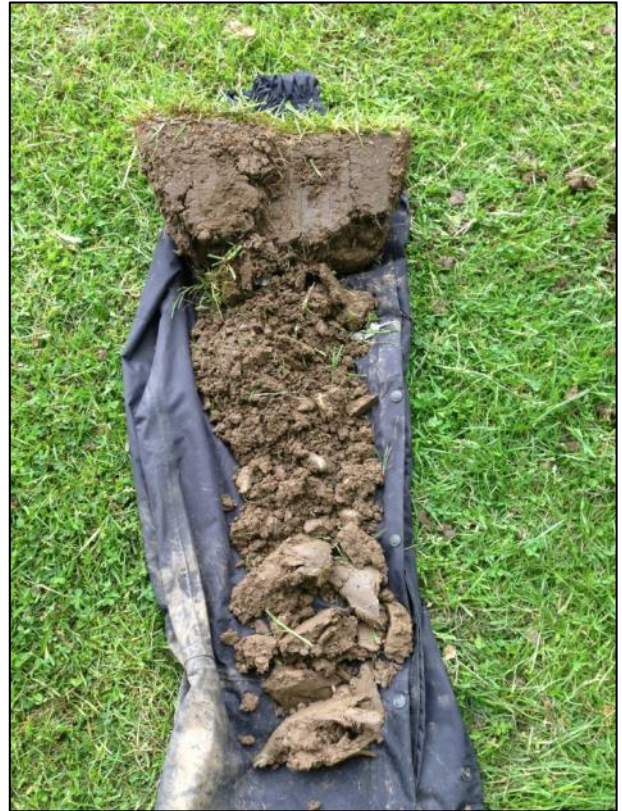
Figure 11 TP2 comprised 450 mm of CLAY LOAM topsoil (very stony).

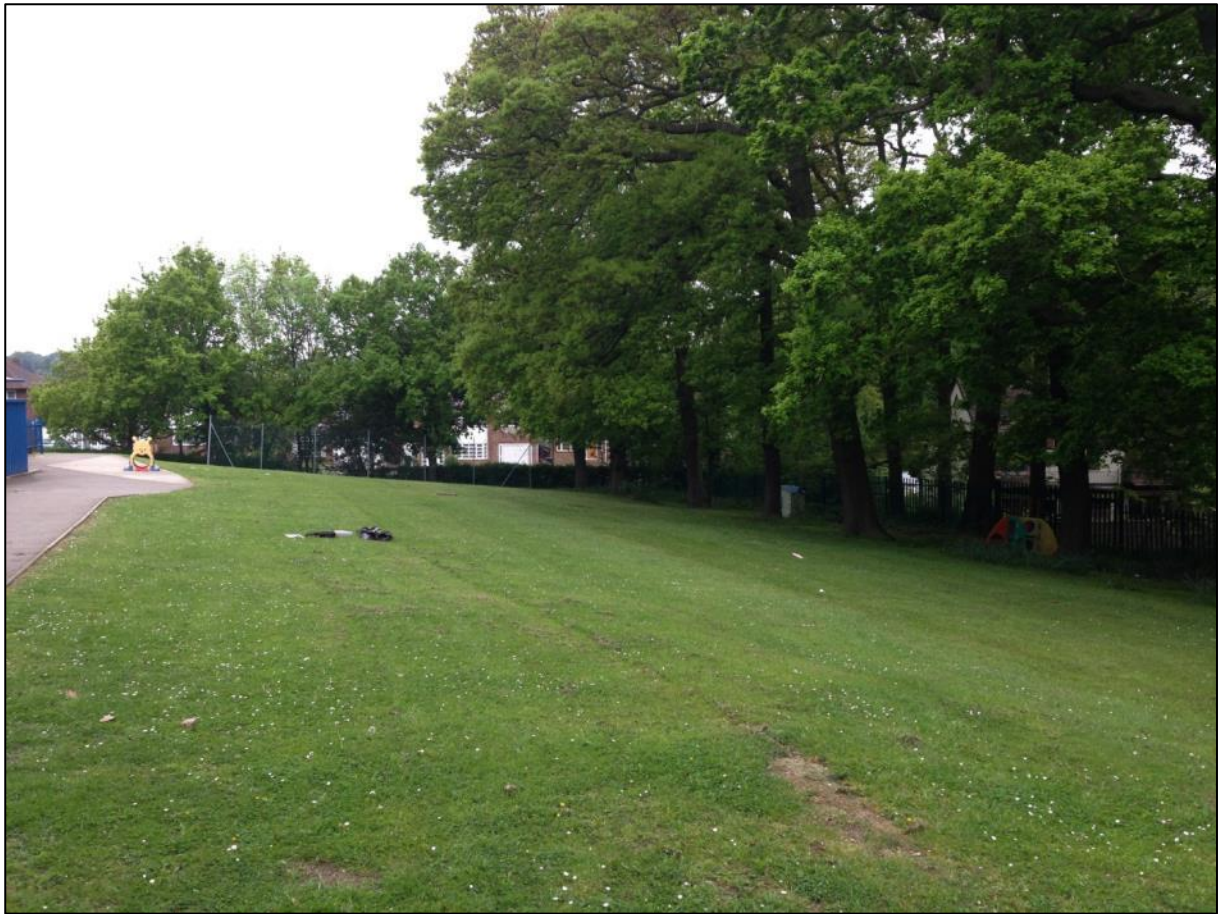
On investigation there appeared to be no existing land drainage infrastructure. This is not surprising given the steep gradients across the site (Figure 13), the soil characteristics and size of the site - all factors which would contribute to the movement and shedding of excess water away from the school and recreation area. The underlying soil characteristics are of a type whereby infiltration rates will be extremely low. With potential outfall identified and located in the NE boundary of the site, the instalment of a land drainage scheme would be recommended. However this would have to be more thoroughly investigated during the design process.

Figure 13. Example of fall away from the school for the removal of excess water

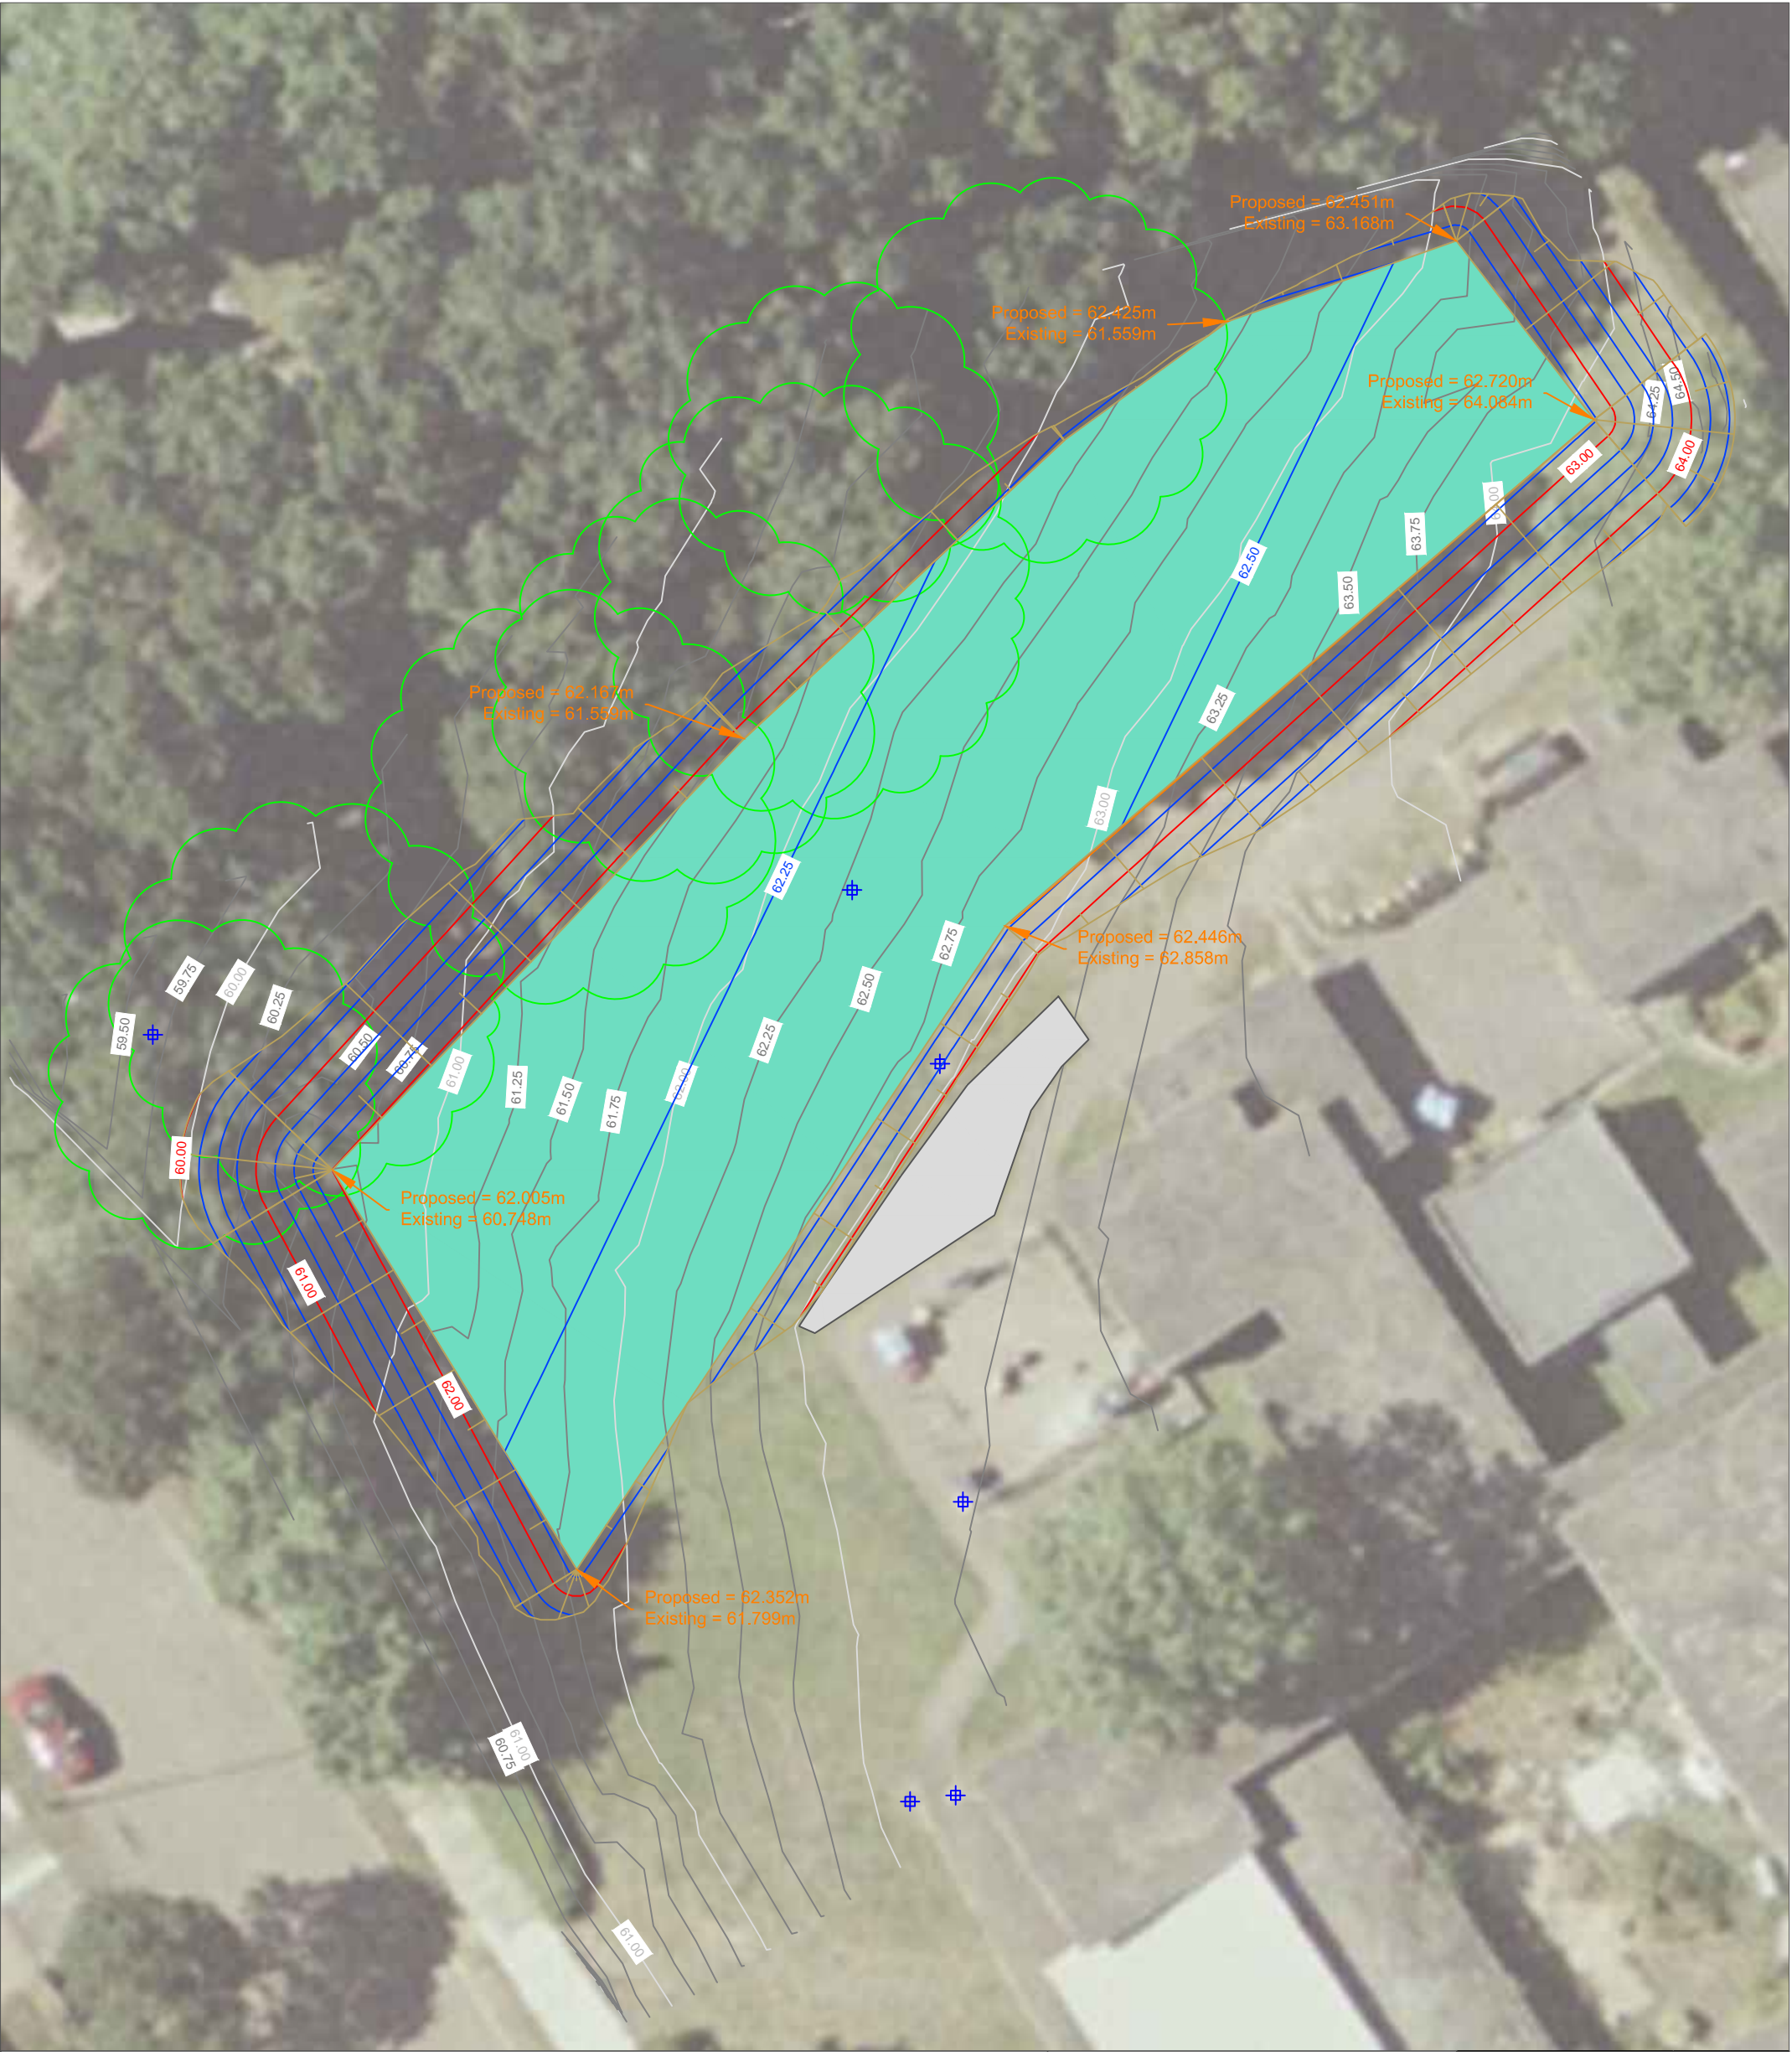
Appendix III: Development Option Drawings

2.	The first option is recommended and comprises the removal of existing vegetation, site remodelling (cut and fill earthworks) and the installation of a retaining wall to maximise the area available for recreational use. This option (Option 3 in the report) would also include the installation of a land drainage scheme so that the area can be used all year round. Estimated costs for this preferred option are £20,769.78 + £2,000.00 for a 12 month maintenance programme to run concurrently with the defects liability period (excluding professional fees and VAT). In addition, it will be necessary to install of some form of pedestrian guardrail to restrict pupils from accessing the recreation area in an unsafe manner. Specialist advice on the most appropriate form and cost of this will be required.

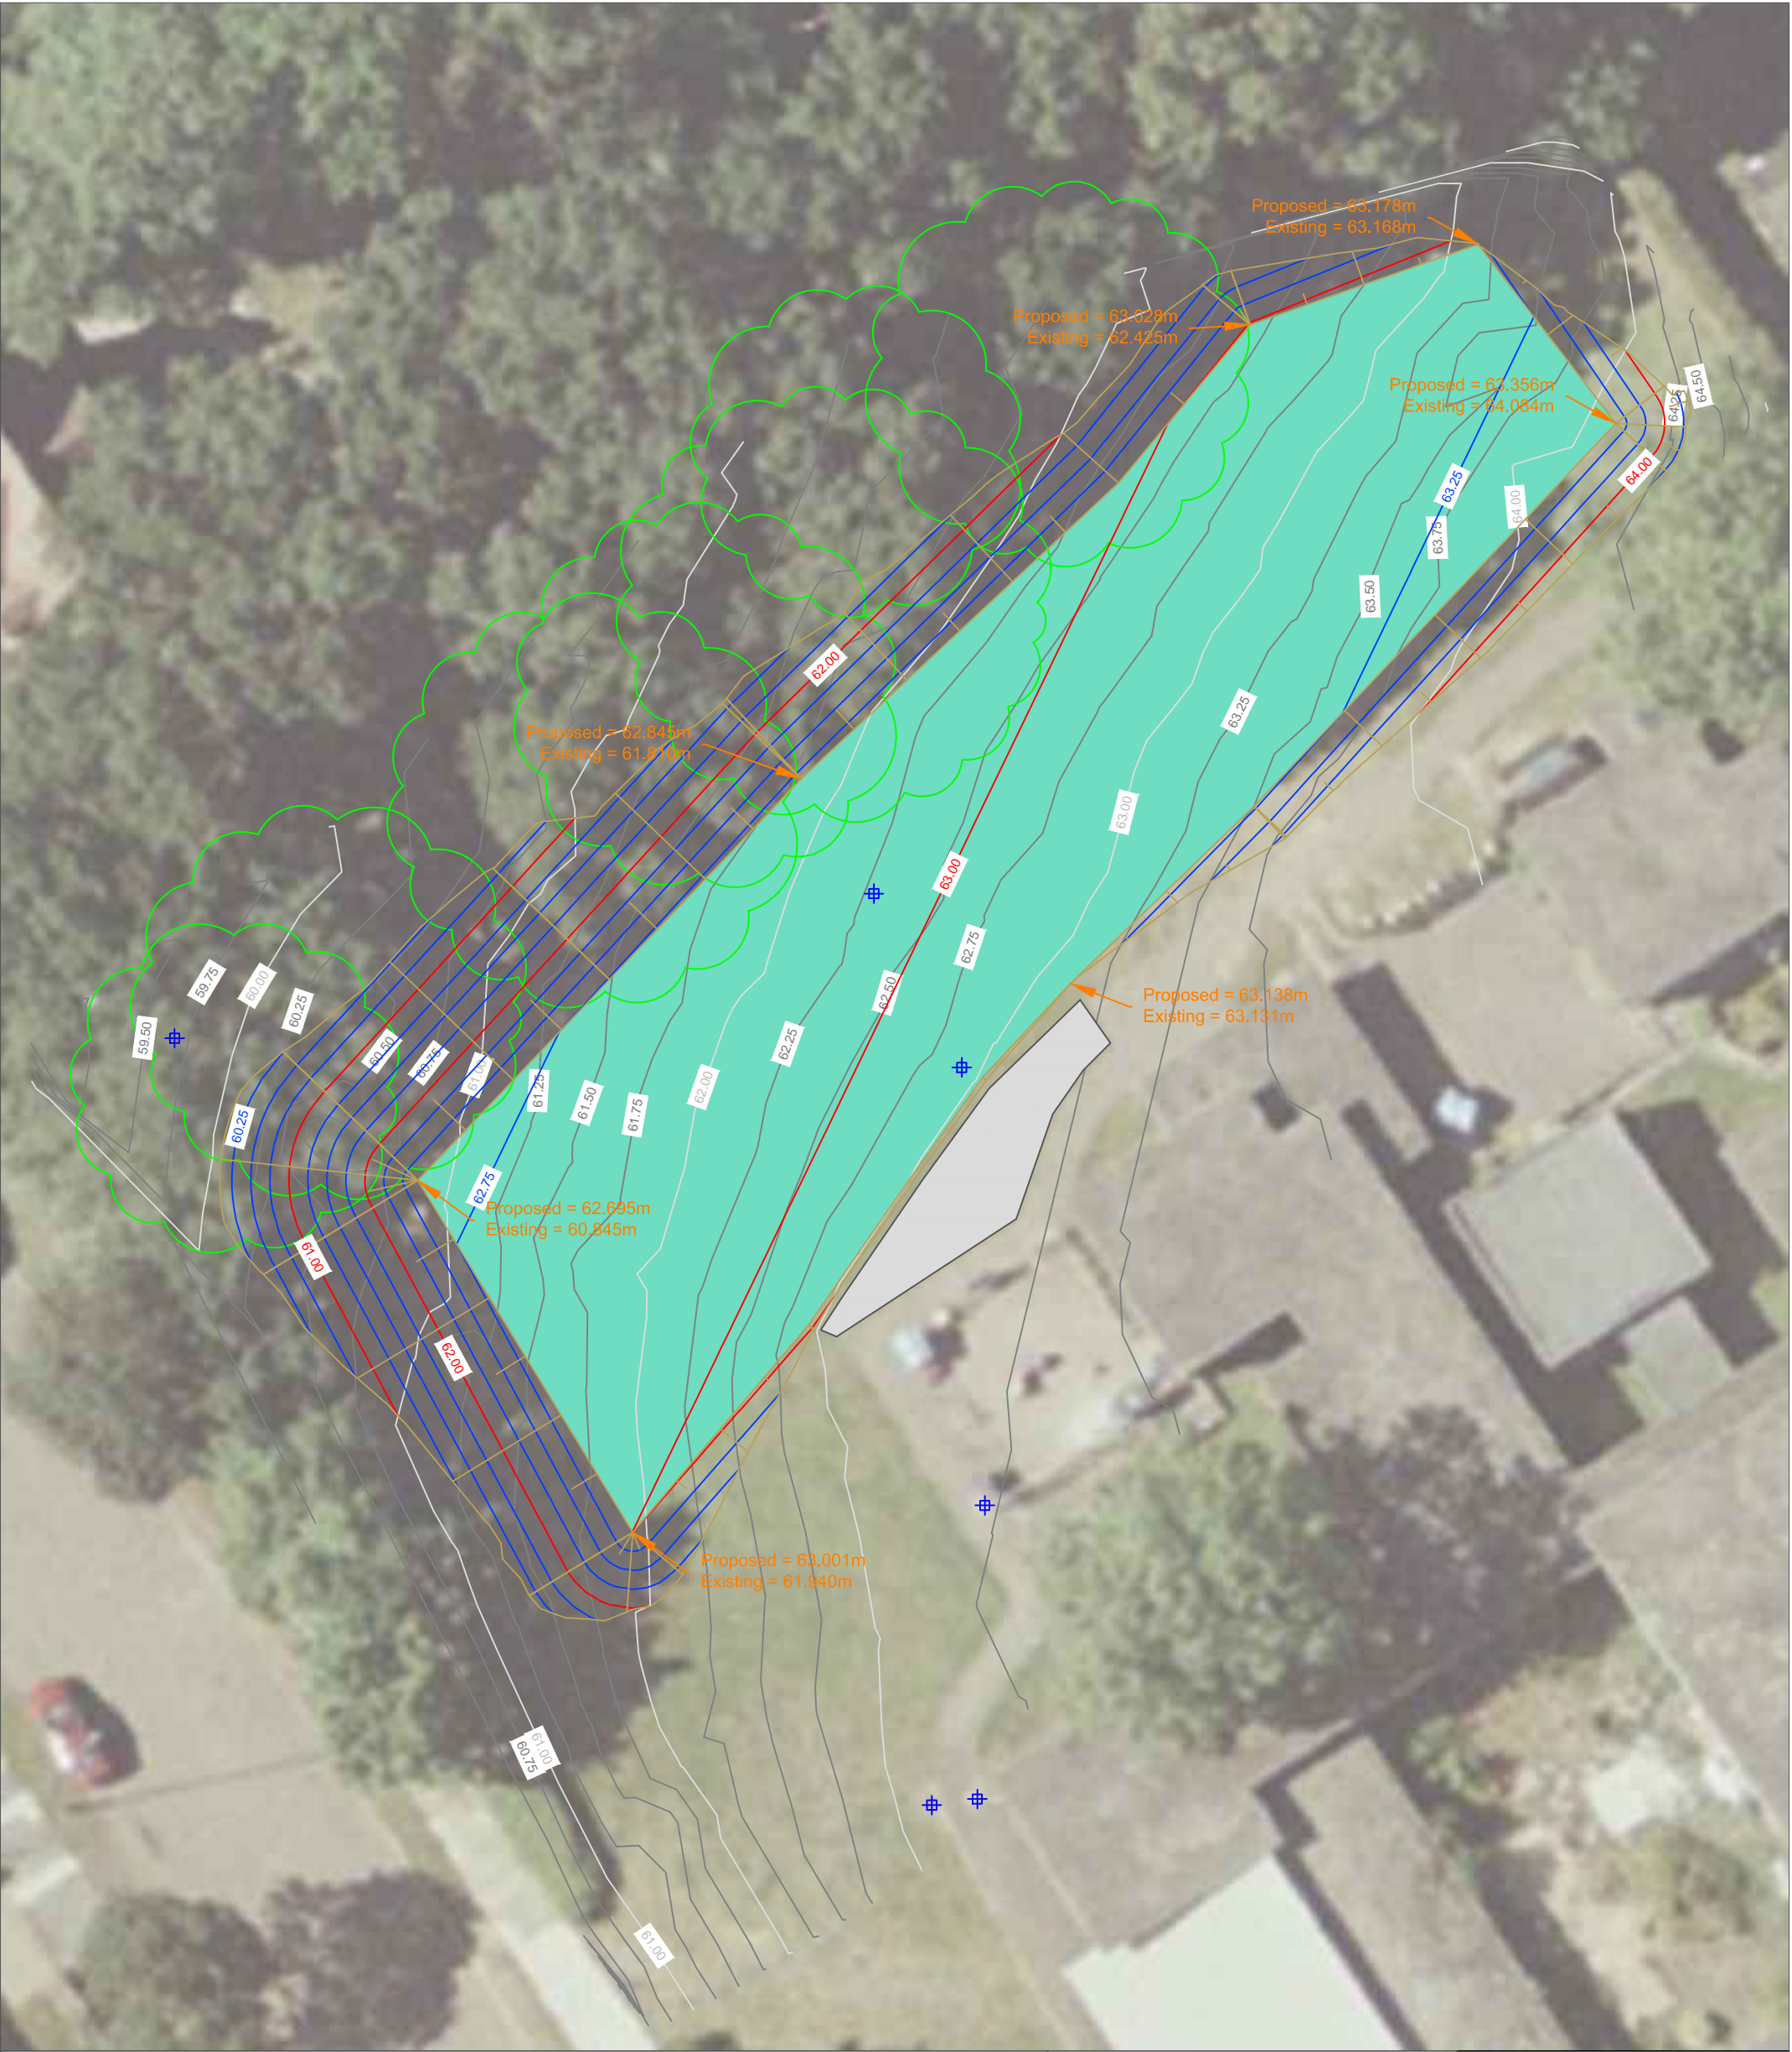
3.	The second option comprises the removal of vegetation, site remodelling comprising a balanced cut and fill operation to construct a plateau bordered by adjacent batter slopes. This option (Option 1 in the report) would also include the installation of a land drainage scheme. Available recreation space (m ²) would be slightly less than that for Option 3. Estimated costs for this option are £13,802.25 + £2,000.00 for a 12 month maintenance programme to run concurrently with the defects liability period (excluding professional fees and VAT).

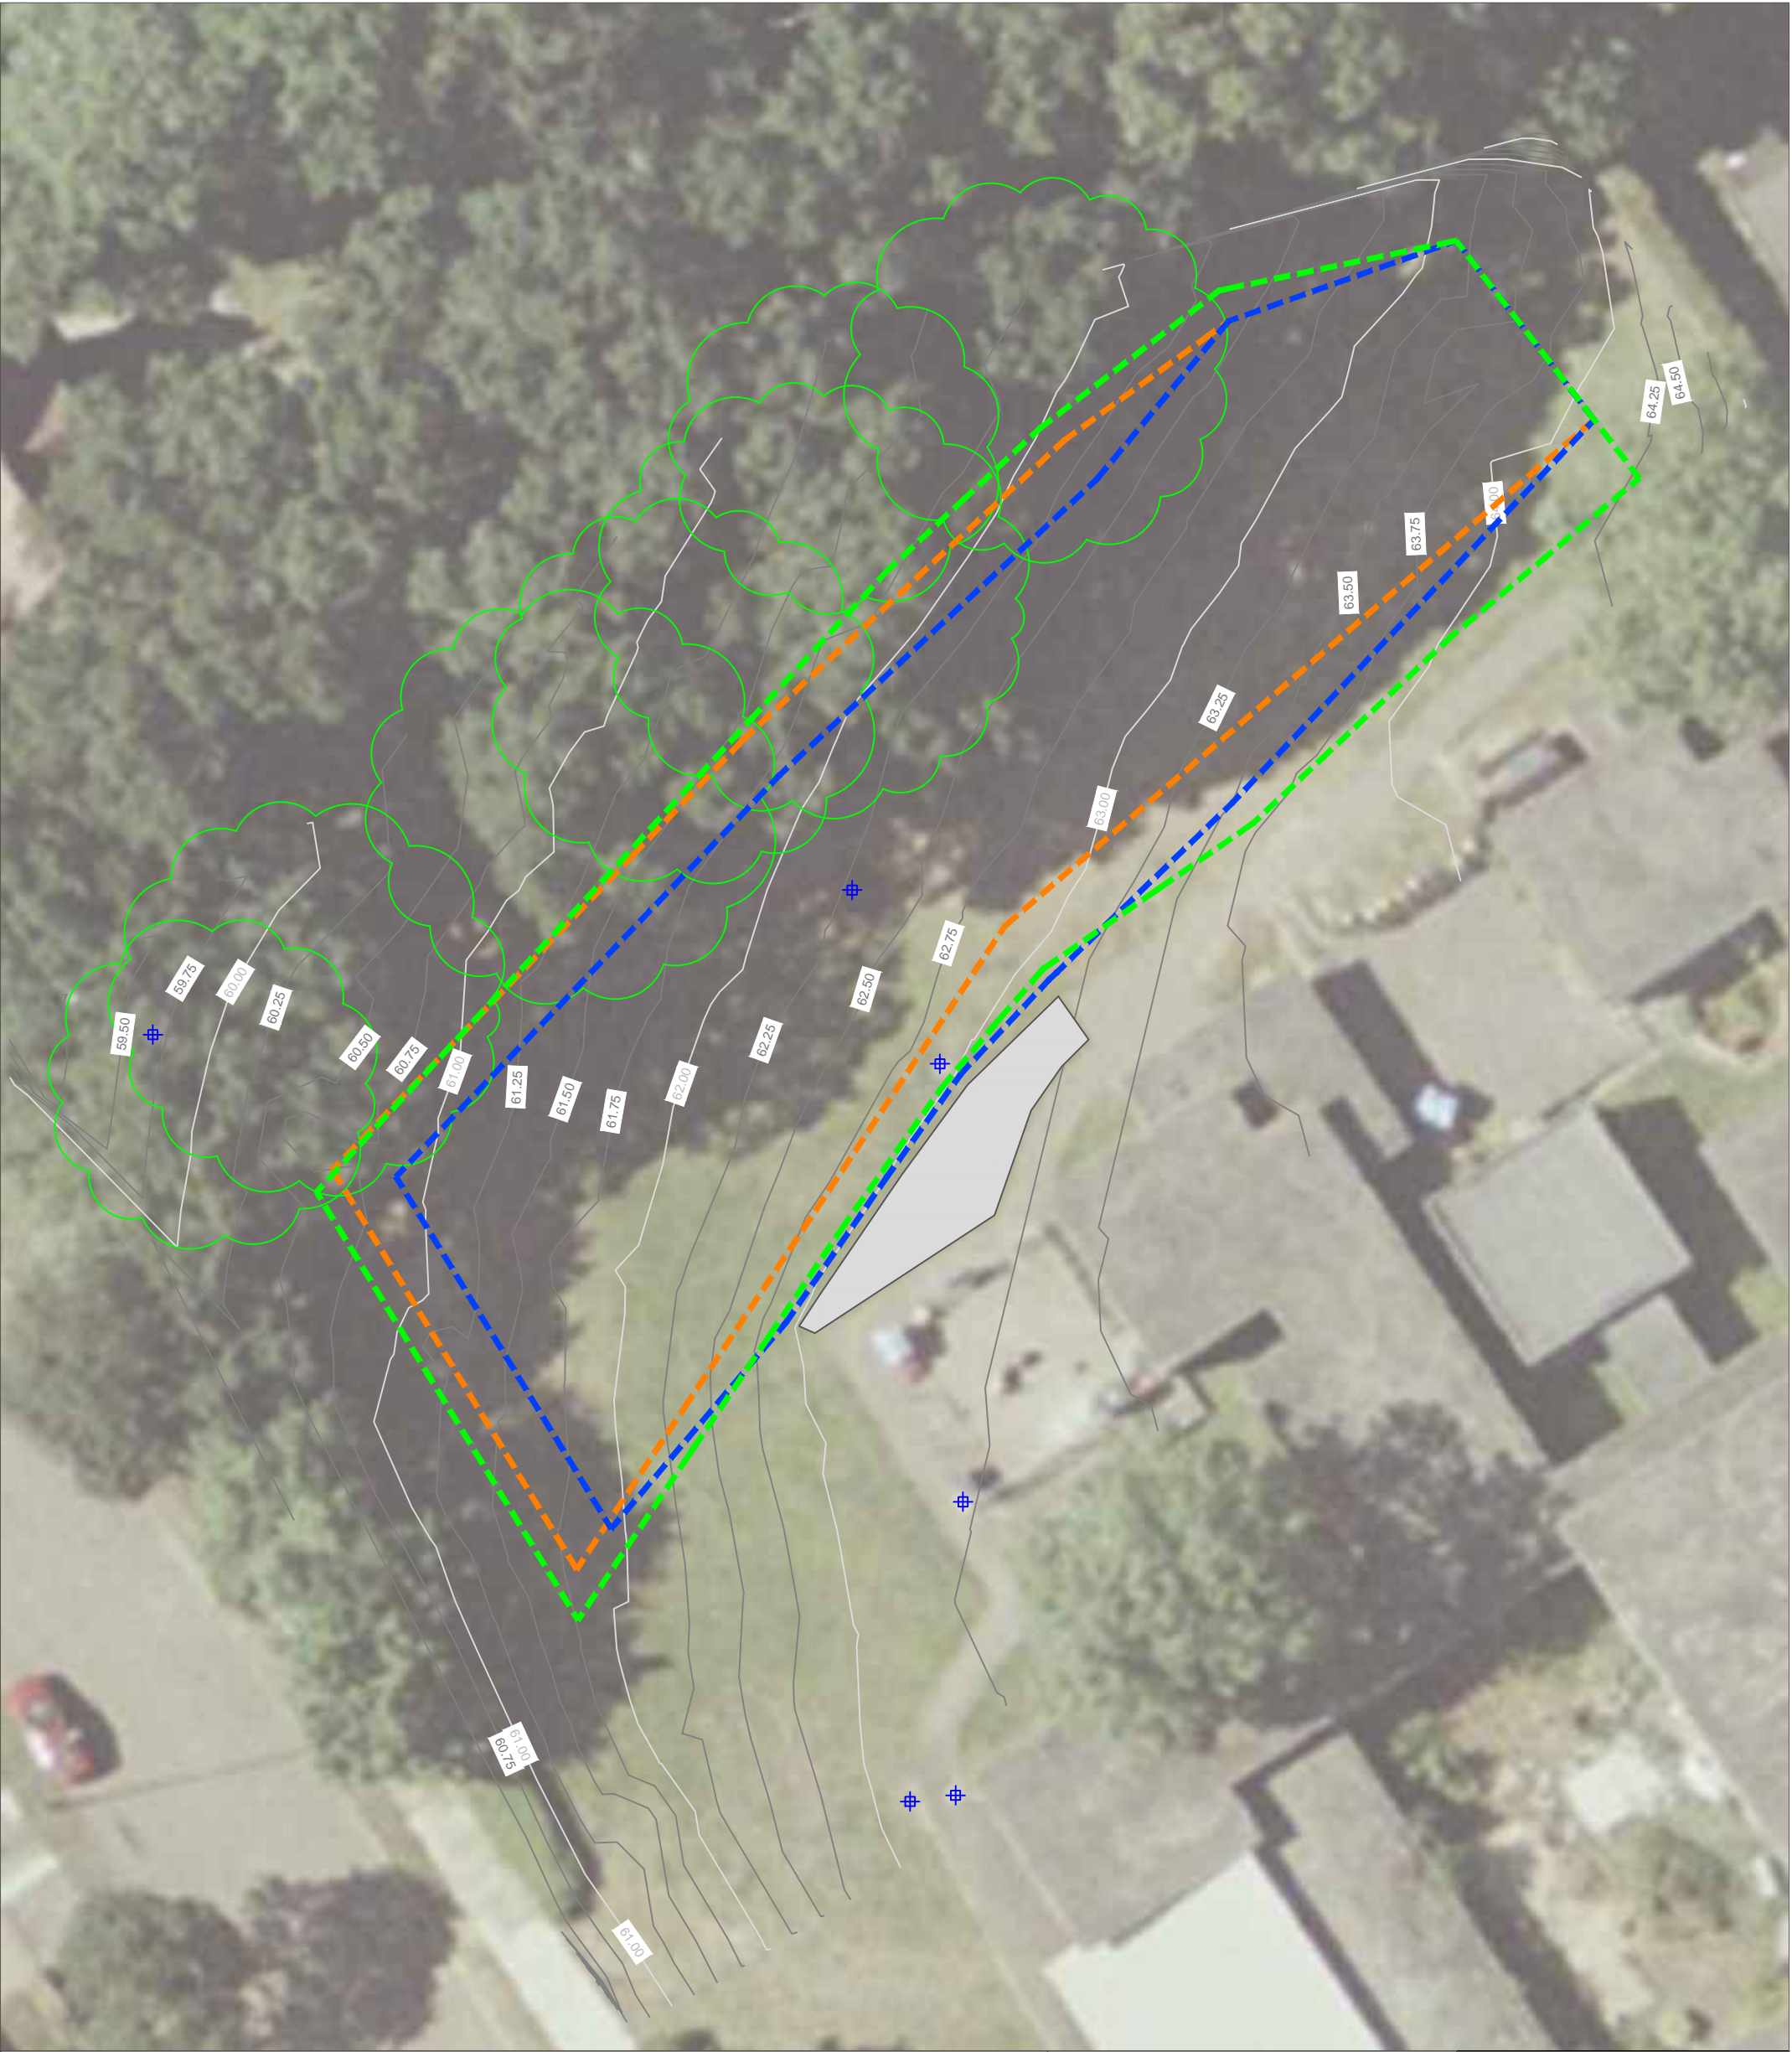
- LEGEND**
- Existing Levels
 - Major Contours - 1m Intervals
 - Minor Contours - 25cm Intervals
 - Inspection Chambers
 - Option 1 - Usable Area (797m²)
 - Option 2 - Usable Area (762m²)
 - Option 3 - Usable Area (979m²)
