A REPORT TO ANY TOWN PRIMARY SCHOOL

A feasibility study for proposed improvement works to the playing field at Any Town Primary School.

17 July 2013

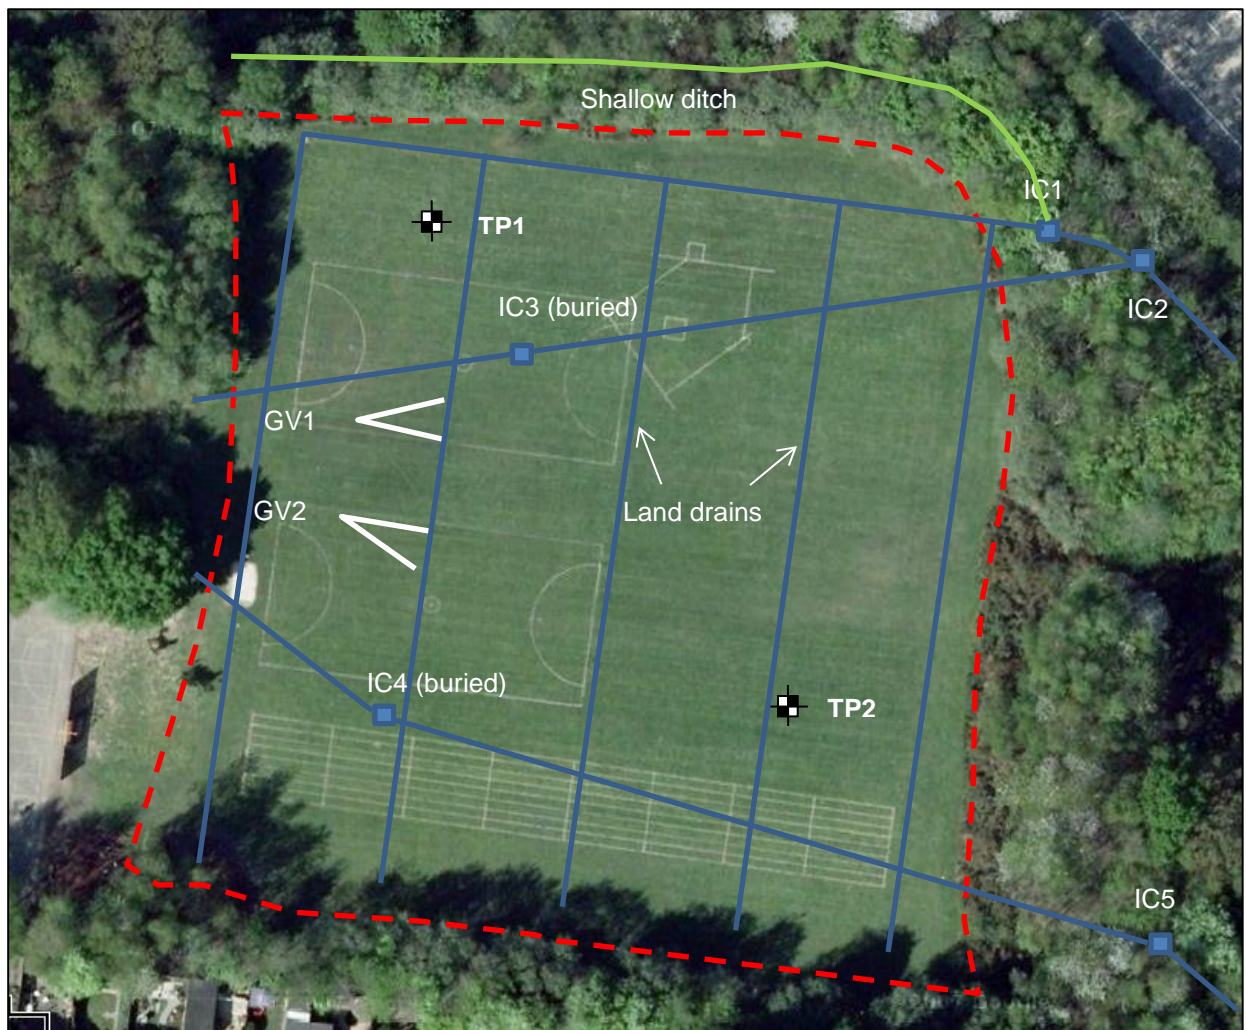
A copy of the land drainage layout drawing was made available which indicates that the scheme was installed around 1990 and comprised a system of widely spaced (~20 m apart) lateral drains in combination with sand slits installed at 2 m spacing, outfalling into an inspection chamber to the east of the site. Approximate locations of the drains are presented in Figure 4.

Figure 4 Any Town Primary School re-development. TP1 and TP2 mark the location of the trial pits. The dashed red line indicates the site development area (indicative only –not to scale). GV1 and GV2 are general views of the site and refer to Figure 2 and Figure 3 respectively. 'IC' represents an inspection chamber on site and the blue lines represent the approximate location of drains.

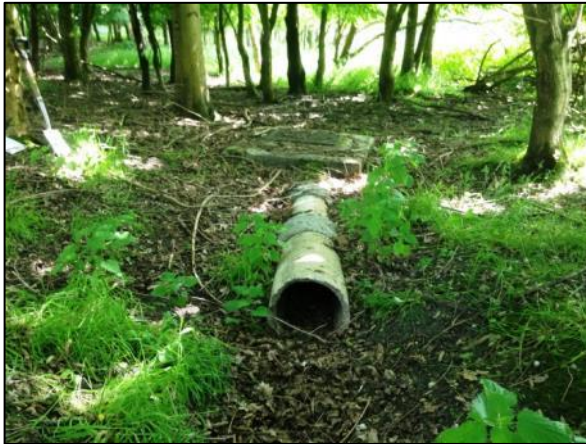
A shallow ditch runs parallel with the northern site boundary and terminates in IC 1 (Figures 5 & 6). With respect to climate, data obtained from the Flood Estimation Handbook (FEH) indicate that the standard-period average annual rainfall (SAAR) is 806 mm for this catchment. Based on existing levels (provided by TGMS) and using the methodology for calculating peak flood flow developed by ADAS¹, it is estimated that the peak flood flow rates will be **8.6 L s⁻¹ ha⁻¹**; this method is based on a 1:5 year rainfall return event.

Figure 5. Shallow ditch running into IC 1

3. A shallow ditch runs parallel with the northern site boundary and terminates in an inspection chamber. This inspection chamber would provide a convenient means of disposal of excess water should a new land drainage scheme be installed.

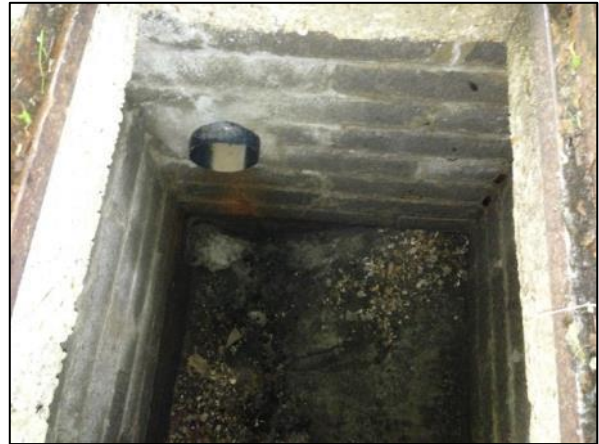
Figure 6. 150 mm carrier drain connected to IC 1.

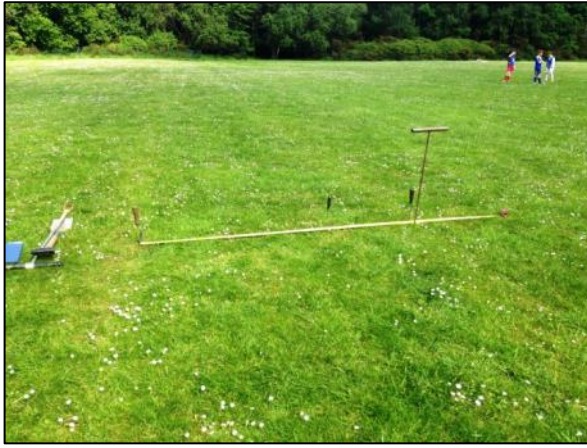
Figure 9. Locating drains using a spiked probe.

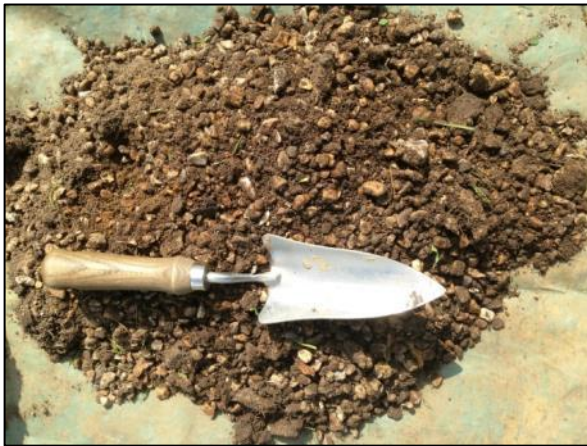
TP1 was located towards the north-western corner of the site in an area demarcated by the EMI scan as being relatively wetter and/or more clayey. The lateral drain was found to comprise 60 mm of loamy sand topsoil over sand to 100 mm depth over 6 to 14 mm gravel over a 60 mm diameter pipe with a soffit at 490 mm below ground level (bgl). The gravel was contaminated with ingress of soil which will be compromising permeability (Figure 11).

Figure 11. Gravel contaminated with soil.

It is concluded that the drainage status in the vicinity of TP 1 is being compromised through a combination of drainage infrastructure being capped off with 60 mm of topsoil, contamination

of the permeable backfill in the drains with soil, excessively wide spacing of lateral drains (20 m whereas a spacing of 3 to 4 m is recommended), general compaction of the topsoil as a result of playing on the pitches in wet conditions and a lack of decompaction operations as part of a routine maintenance schedule.

In order to correct this situation, consideration should be given to the installation of a new surface by-pass drainage system. These systems work by intercepting rain water at the surface before it has had an opportunity to soak in to the soil profile, and then removing this water to a system of piped drains. Typical systems would comprise sand grooves (Figure 19) linked into a system of lateral drains beneath the playing field.

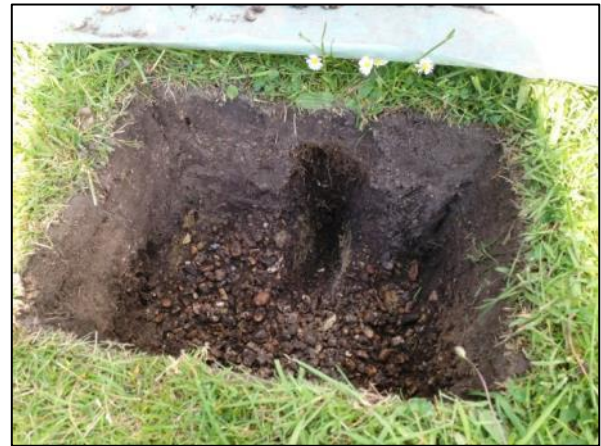
A slit drain intersected the lateral drain at 90° (Figures 10 and 12) and was found to comprise 60 mm of loamy sand topsoil over 6 to 14 mm gravel to 250 mm however the gravel was badly contaminated with soil ingress. For slit drains to function efficiently, it is important that the permeable backfill extends to the surface so that it can intercept surface water and convey it rapidly to the system of lateral drains below. The slit drain excavated at TP1 was found to be capped off by 60 mm of topsoil thereby completely compromising its function.

Figure 12. Excavation of slit drain – TP1.

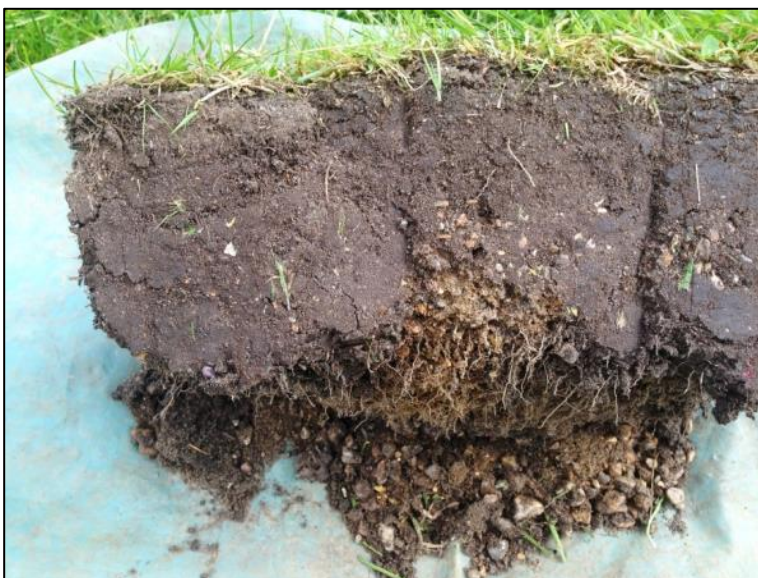
Away from the drain, the underlying soil profile was found to comprise 170 mm of loamy sand topsoil (Figure 13) over yellow sandy loam subsoil to 0.80 m over dark organic-rich subsoil (probably formally the original topsoil prior to earthworks associated with the M27) which extended beyond the maximum depth of excavation of 1.0 m (Figure 14).

Figure 13. 170 mm of topsoil – TP1.

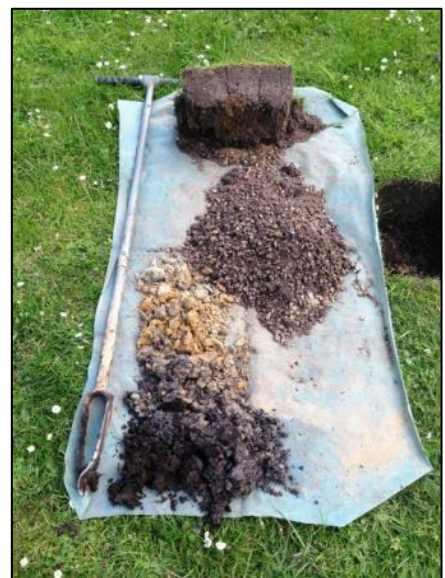
Figure 14. Subsoil – TP1.

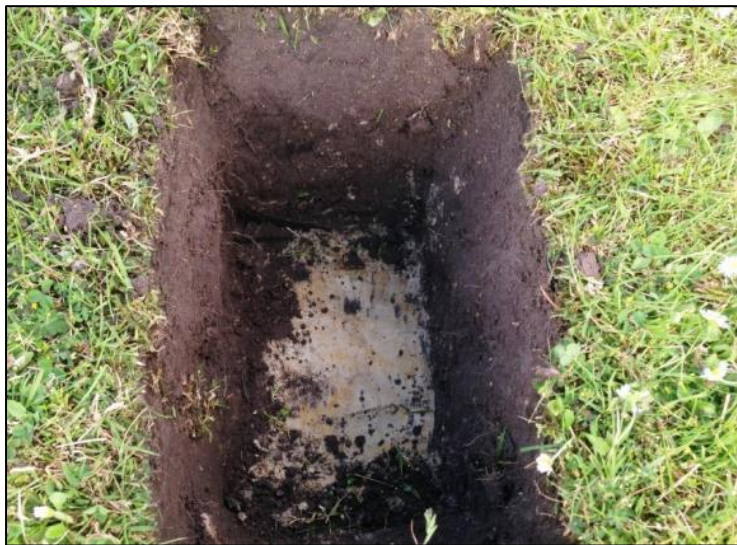
TP2 was located towards the south-eastern corner of the site in an area demarcated by the EMI scan as being relatively drier and/or sandier. The soil profile was found to comprise 200 mm of compact sandy loam topsoil (Figure 15) over compact, light yellow sand which extended beyond the maximum sampling depth of 1.2 m (Figure 16). No ground water was encountered in the upper 1.2 m of the soil profile however there was evidence of mottling (orange discolouration) which is indicative of seasonal waterlogging and so although the sand subsoil is likely to be relatively freely draining, it may be sitting on less permeable strata which could be causing a perched water table to build up in the winter months when the rate of precipitation exceeds the rate of water loss through transpiration through the grass leaves and evaporation from the surface.

Figure 15. 200 mm of topsoil over sand – TP2.

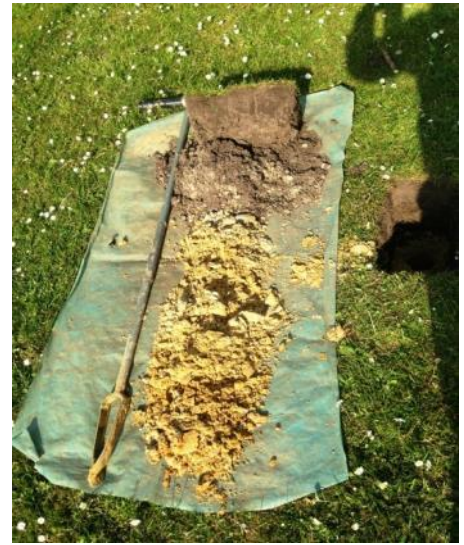
Figure 16. Yellow sand subsoil – TP2.

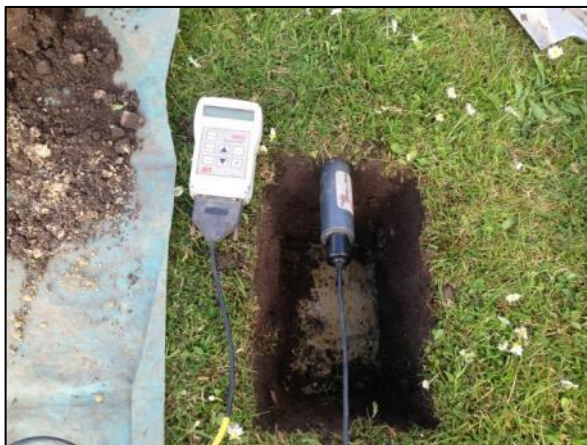
Water content (by volume) was measured using a Theta Probe (Figure 17) and found to be 25.4 % at the surface reducing to 19.2 % at the interface between the topsoil and subsoil. This indicates that the underlying subsoil is relatively freely draining and that the poor drainage status experienced in recent years can be largely attributed to the degree of compaction in the topsoil (Figure 18). An effective land drainage scheme would manage the development of a perched water table in winter.

Figure 17. Measurement of water content using a Theta Probe.

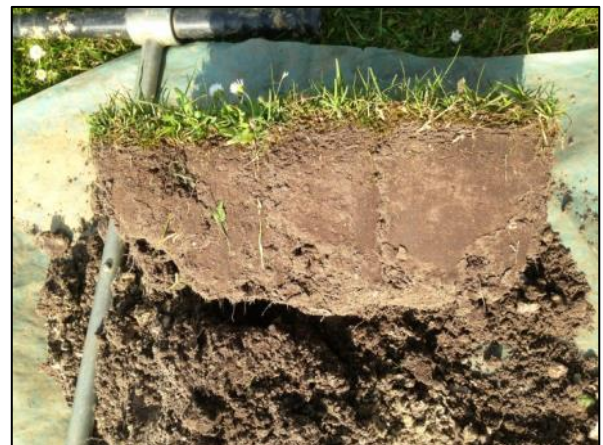
Figure 18. Compact topsoil – TP2.

It is concluded that the drainage status in the vicinity of TP 2 is being compromised through a combination of drainage infrastructure being capped off with 60 mm of topsoil, contamination of the permeable backfill in the drains with soil, excessively wide spacing of lateral drains, general compaction of the topsoil as a result of playing on the pitches in wet conditions and a lack of decompaction operations as part of a routine maintenance schedule.

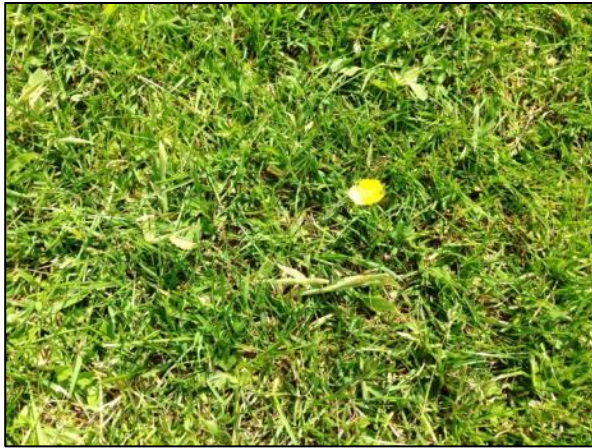
Sward cover ranged from 80 % to 100 % (mean of 95 %) with 30 % to 40 % broad leaved weeds (mainly creeping buttercup, daisy and plantain - Plates 21 & 22).

Plate 21. Creeping buttercup.

The grass condition can be improved by following a careful turf management system encompassing herbicide applications, over-seeding and top dressing to fill any undulations across the site.

Weed control. Apply a selective herbicide in the spring (if required) to combat the weeds present. This to be applied at least two weeks after the first fertiliser treatment (April) and at a time when grass growth is strong and healthy. NB. Do not apply herbicide during periods of potential turf stress, i.e. if the weather is hot and dry or if frosts are forecast. Apply herbicide strictly according to the manufacturers label recommendations and only by suitably qualified personnel.

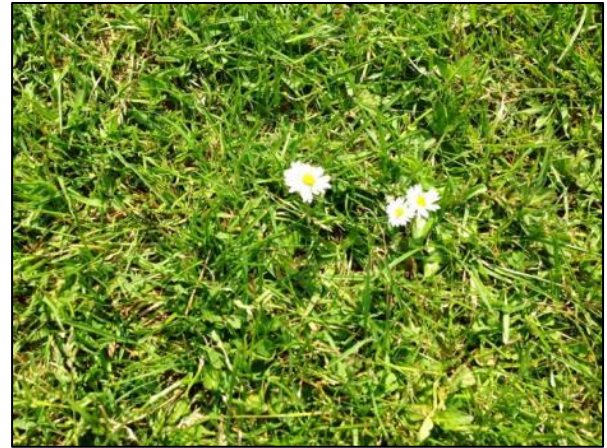
Plate 22. Daisy.

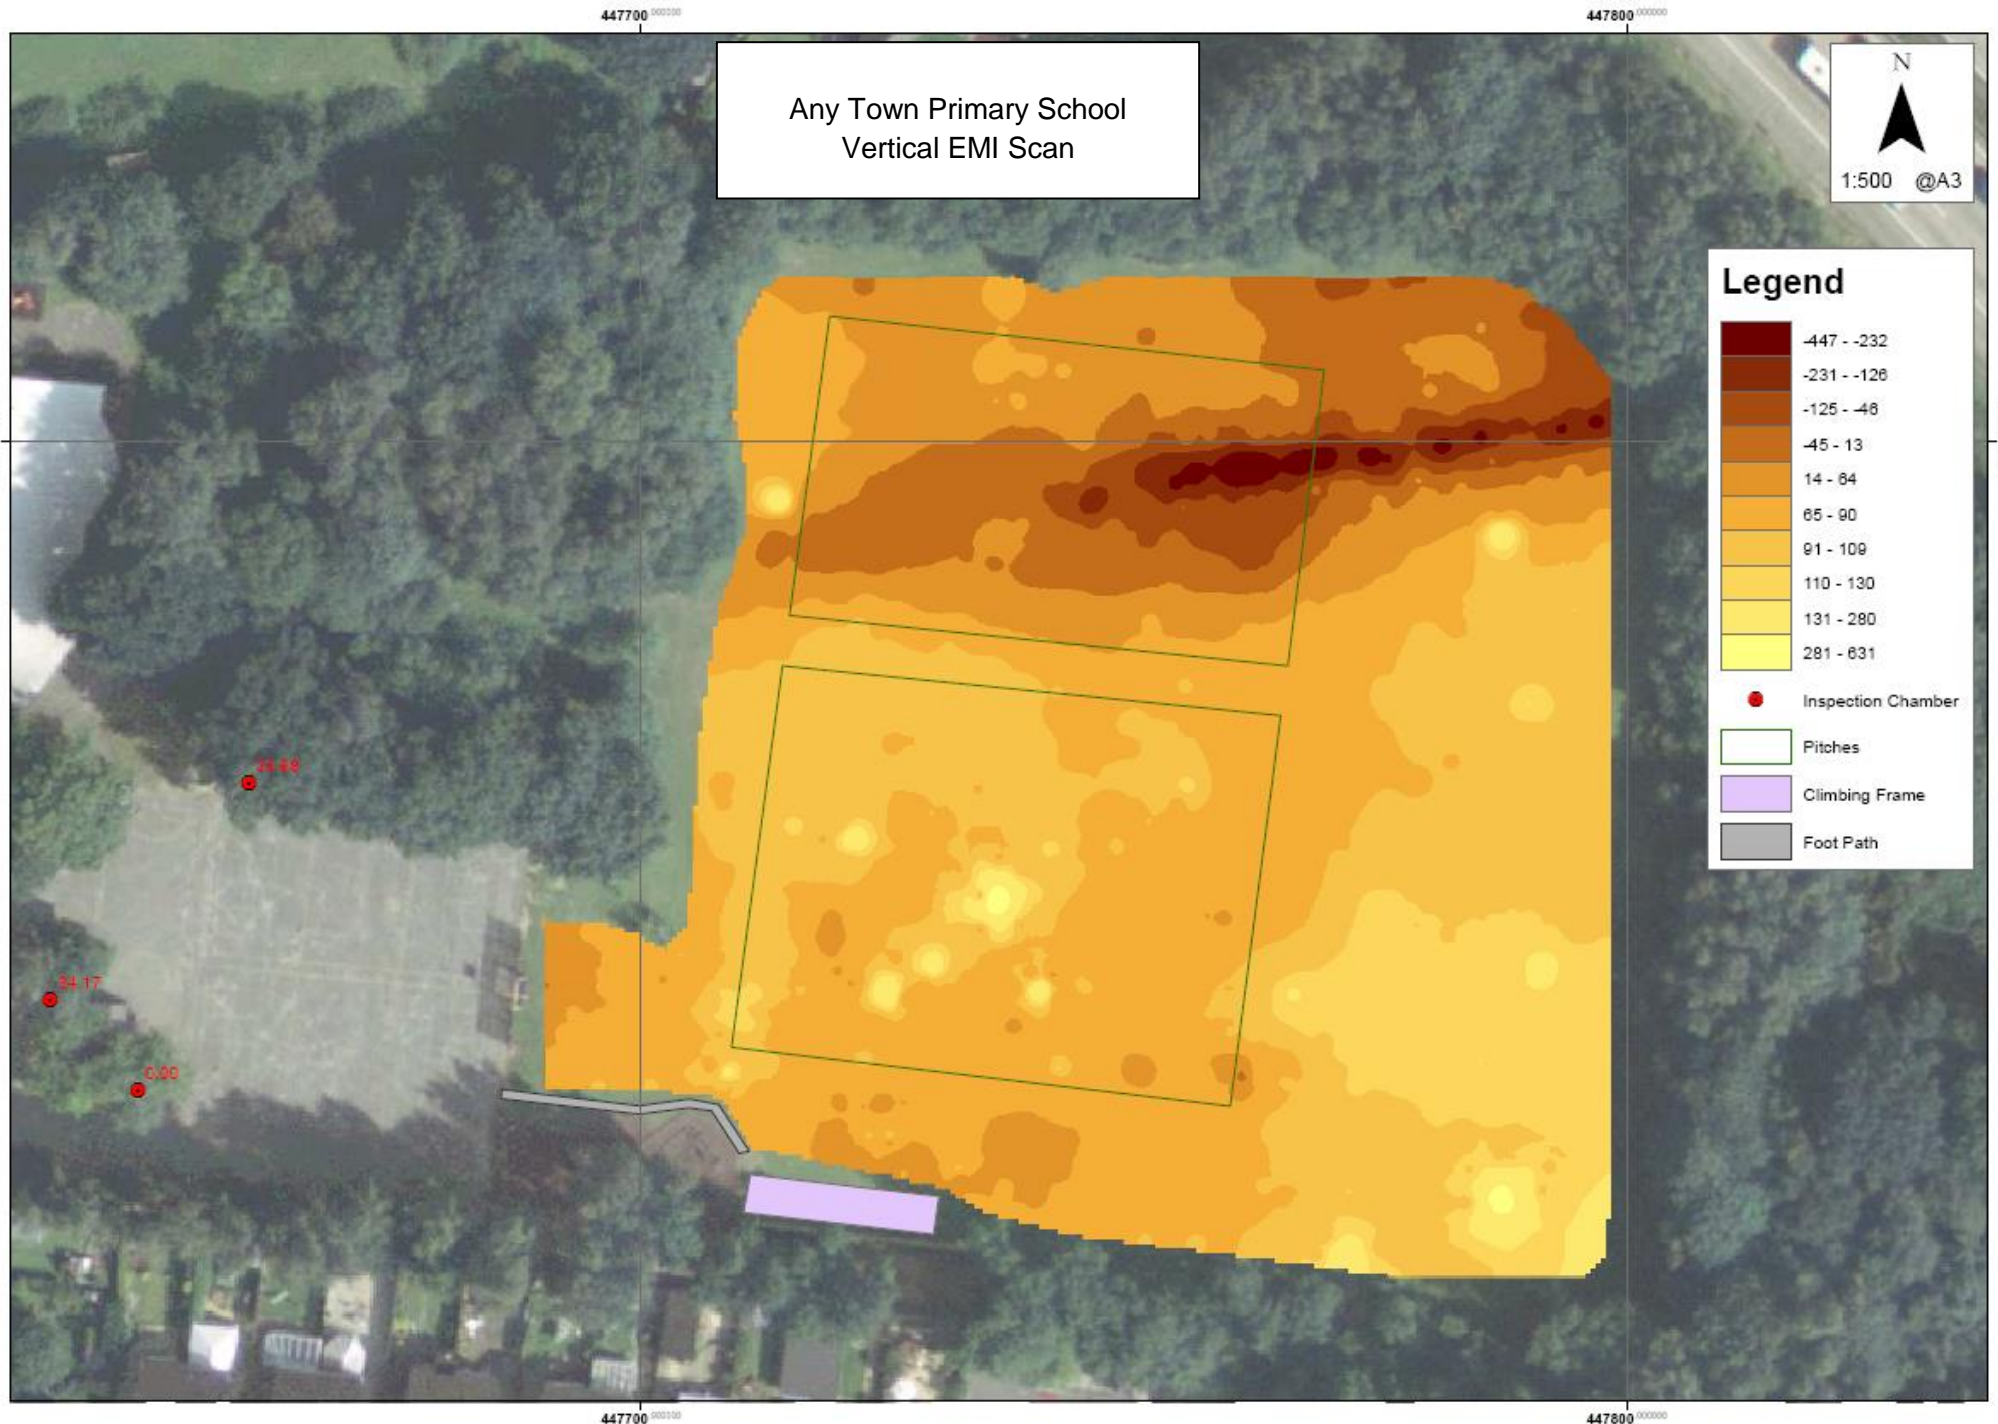
Any Town Primary School
Vertical EMI Scan

EMI maps of the results of scans of the top 0.75 m (termed 'Horizontal EMI Scan') and the top 1.5 m (termed 'Vertical EMI Scan') of the soil beneath the surface of the site are appended. With reference to these figures, lighter coloured areas typically represent drier and/or less clayey conditions whereas darker coloured areas typically represent wetter and/or more clayey conditions. With respect to the EMI scan images, the condition or type of soil across the site varies with wetter and/or more clayey soils in the northern half of the area and drier and/or sandier soils in the south.
