MOWSBURY PARK PLAYING FIELDS

BEDFORD

Status: Completed 2009

Client: Bedford Design Group

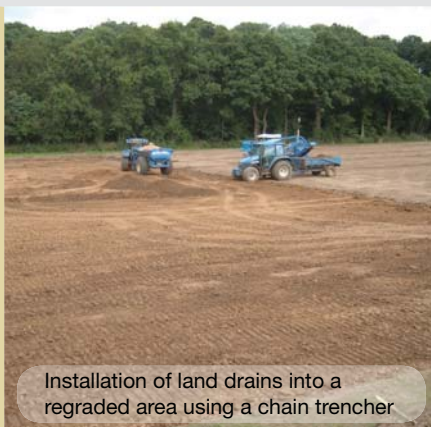
Installation of land drains into a regraded area using a chain trencher

This comprised a series of perforated pipe drains laid in gravel-filled trenches at 7m spacing, in combination with sand slits installed at right-angles to these drains at 2m spacing. In addition to this, sand grooves were also installed on a proportion of pitches where the drainage problems (i.e. areas with the highest clay content) were most severe.

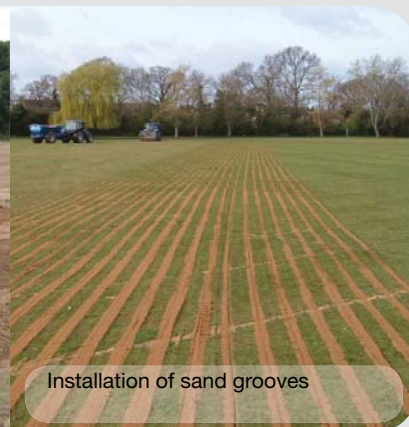
Installation of sand grooves

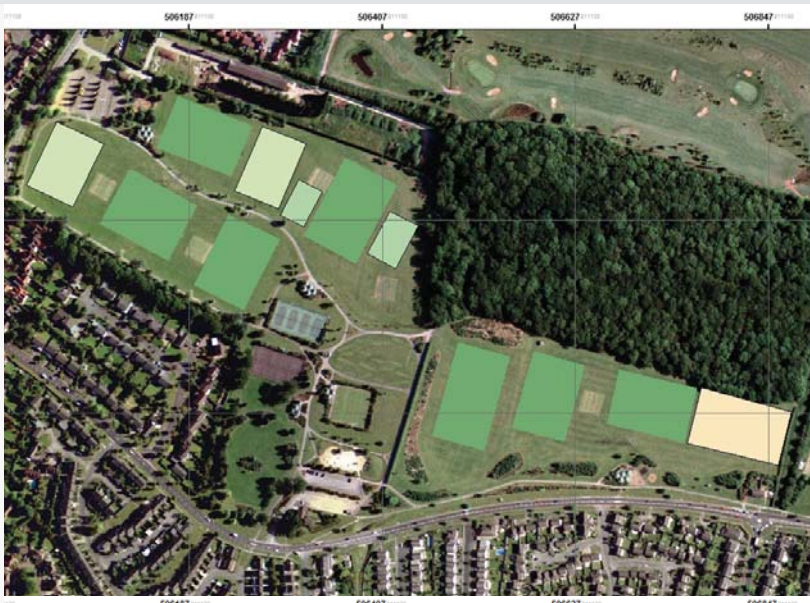
Existing Pitch Layout

- Mini Football Pitch
- Junior Football Pitch
- Senior Football Pitch
- Rugby Pitch
